**INVESTIGATION OF  
PERFORMANCE OF GRANULAR BASE AGGREGATES  
FROM THE  
DUNDEE & DETROIT RIVER CARBONATE ROCKS  
IN ESSEX COUNTY**

by  
Z. Koniuszy, P. Eng.  
Geologist  
and  
Z.L. Katona, P. Eng.  
Senior Aggregate Resources Engineer

SOILS AND AGGREGATES SECTION  
ENGINEERING MATERIALS OFFICE

August 1981

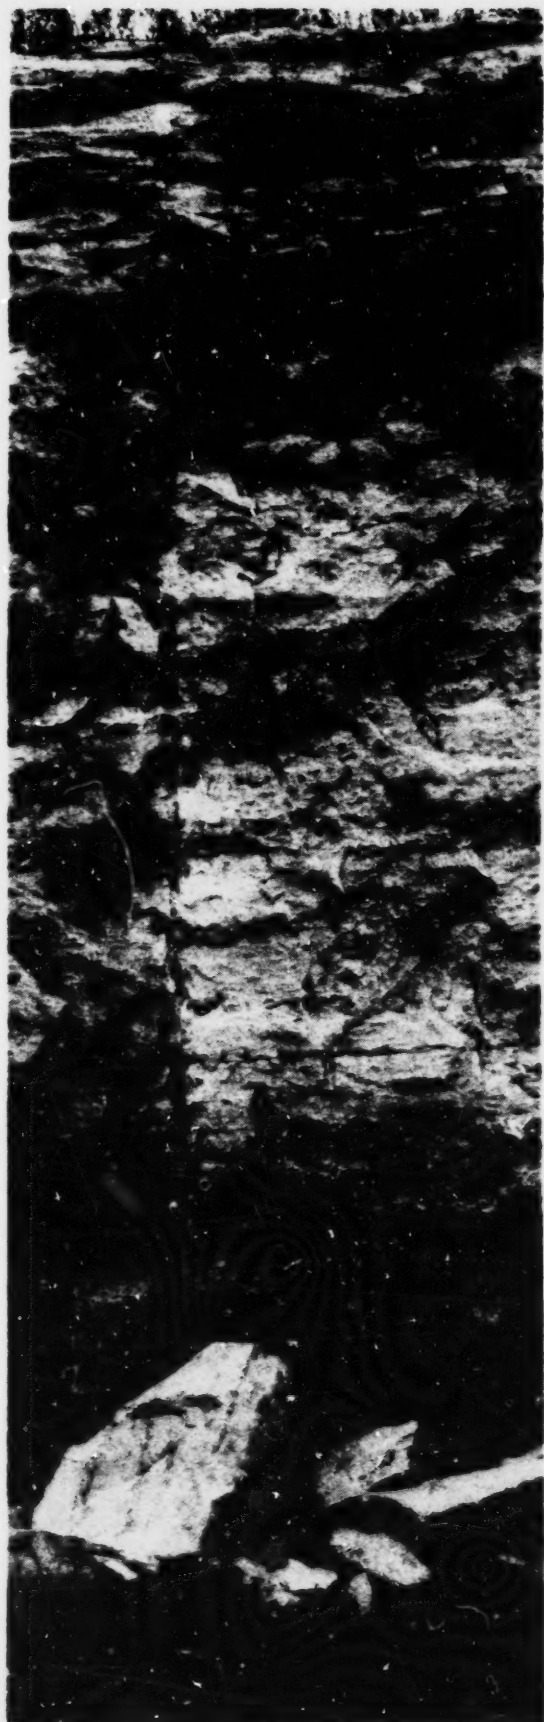
Figure 6

exposed beds belong to the Dundee Formation and are described in Figure 6.

Limestone and dolomitic limestone,  
buff to light grey, fine sugary  
texture. Soft to medium hard. In  
places, heavy concentration of  
organic matter and discolouration  
of limestone by crude oil. Rocks  
exude characteristics strong oily  
smell. Massive bedding. Same  
light colour chert nodules and  
sandy pieces found in blasted  
rock on quarry floor.

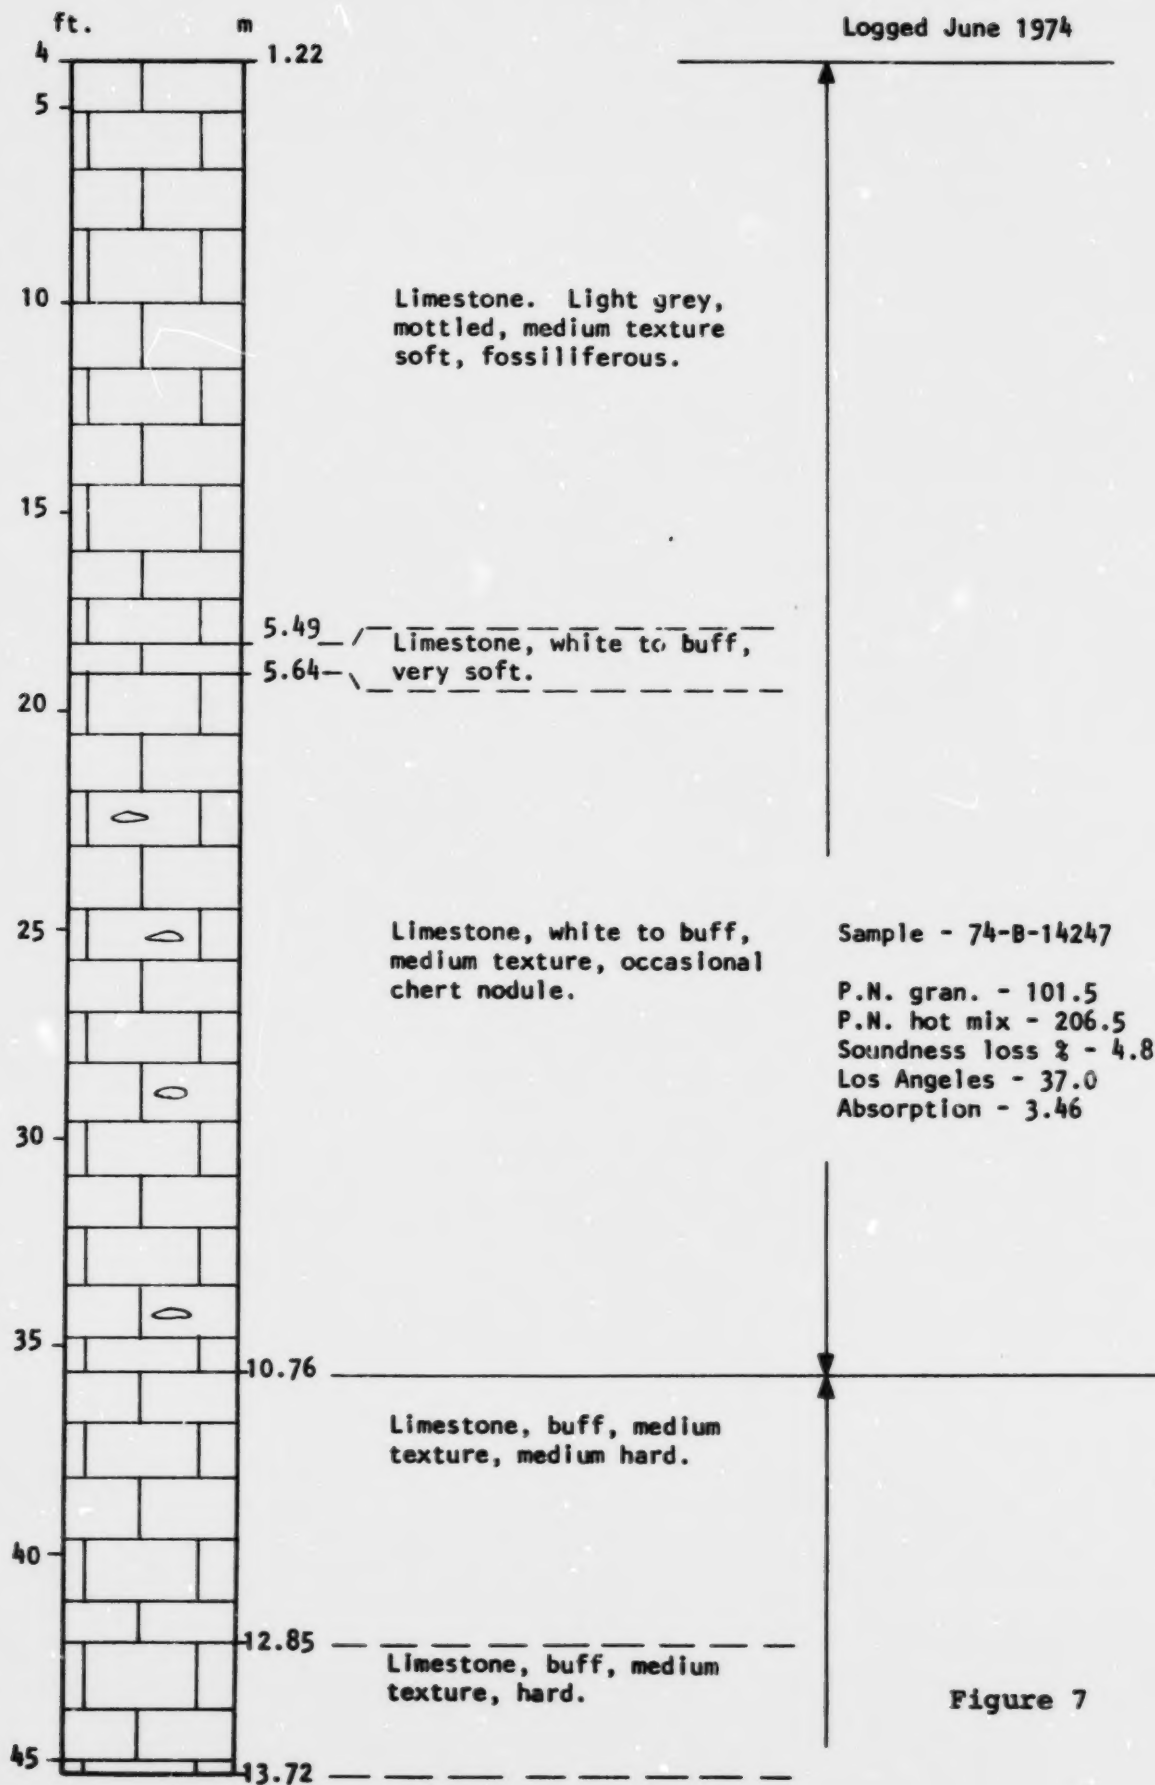
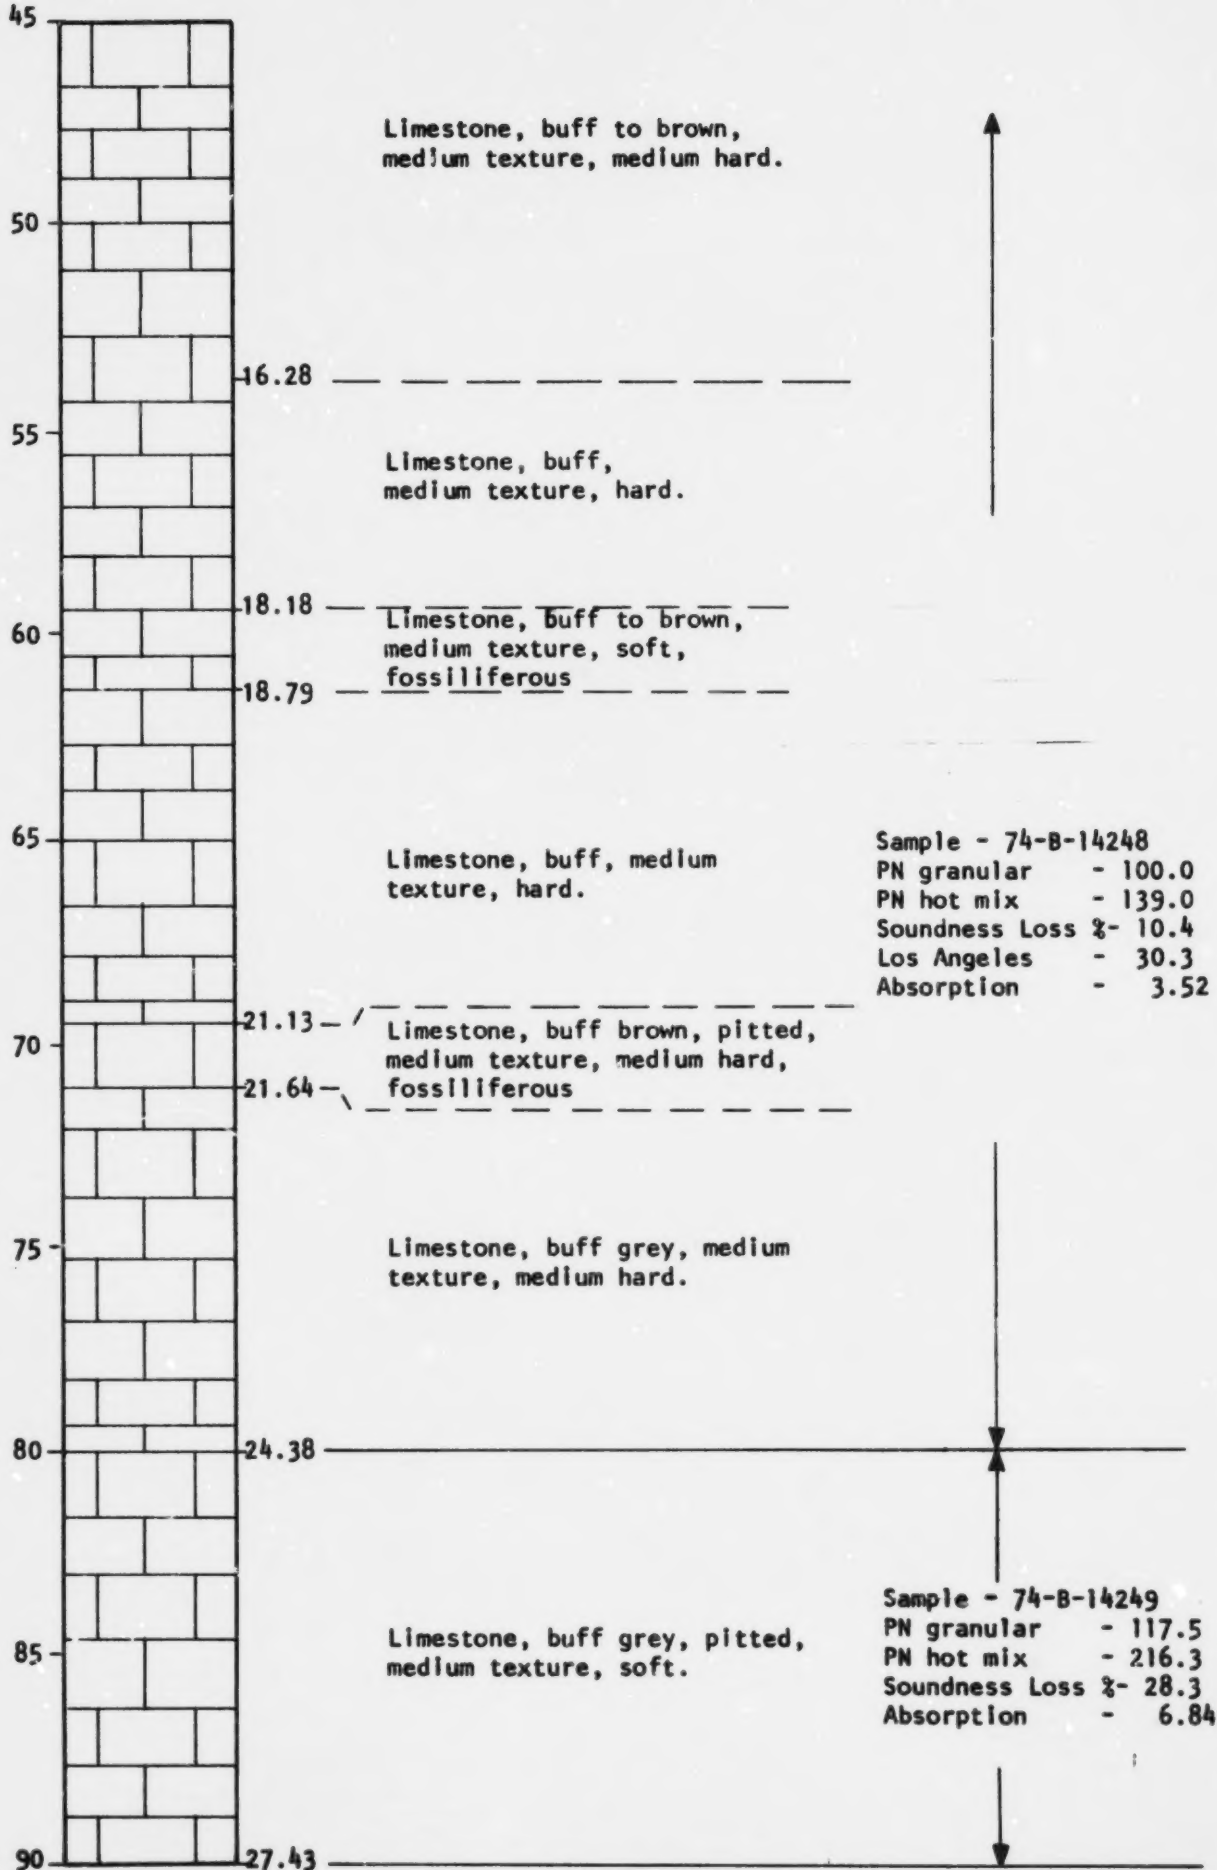
Figure 7

In 1974, the quarry was diamond drilled by Marentette Brothers. The core was sent to the Ministry for logging and laboratory testing. On the basis of the log, the core was sectioned off and each section was tested separately. The quality of each level represented by the core was as follows: (Figure 7)

PELEE QUARRIES INC.  
DIAMOND DRILL CORE LOG

Logged June 1974

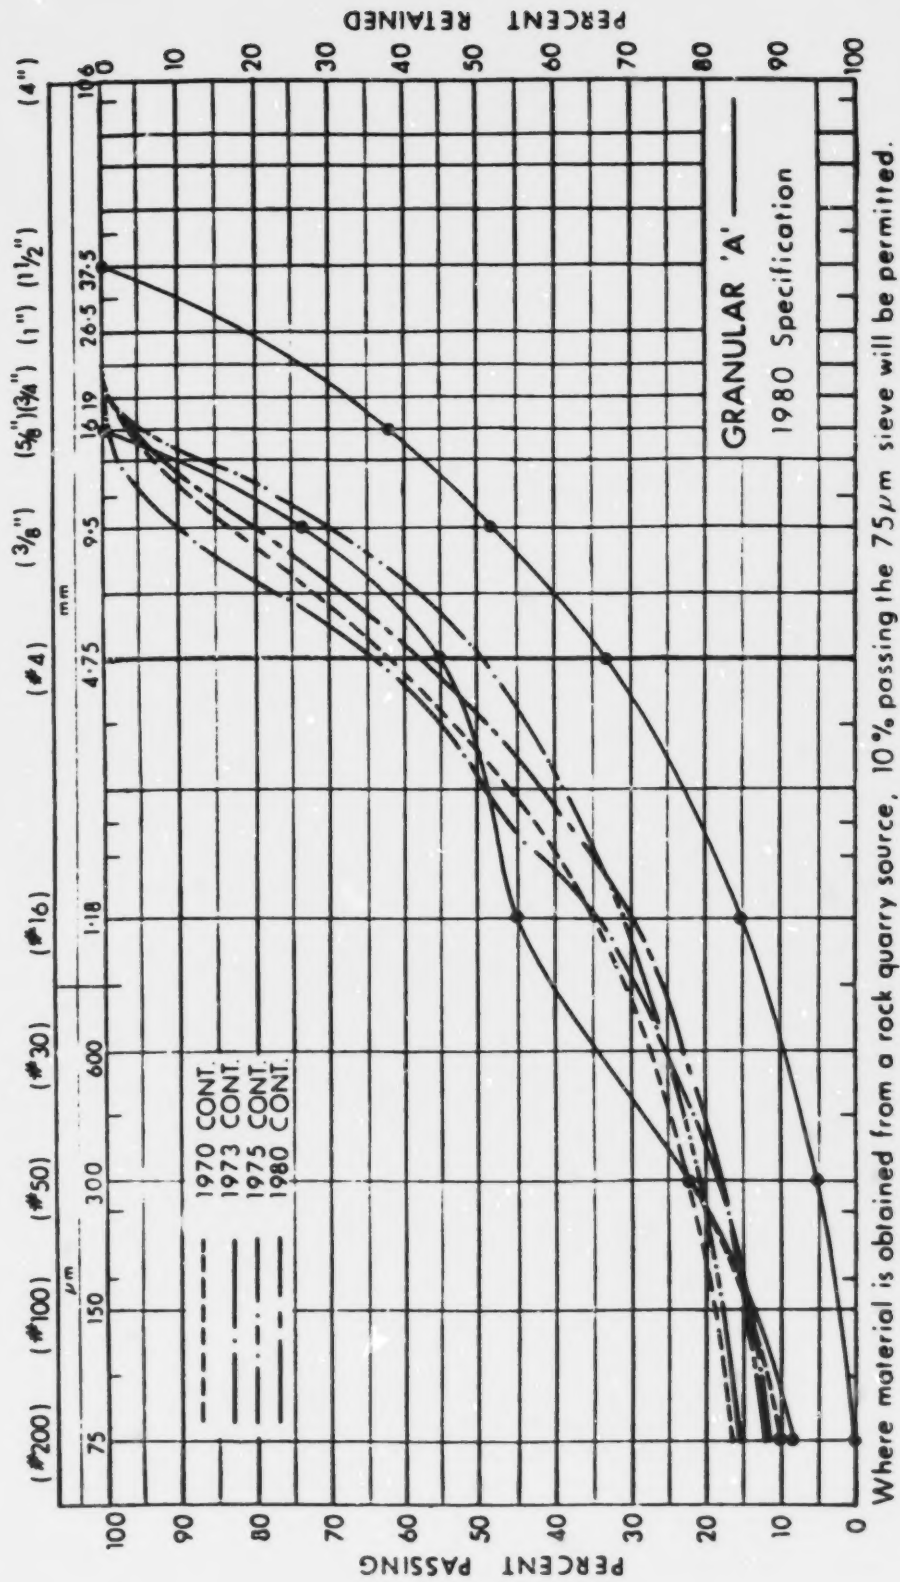
FIG. 8

Granular base material from nine locations was removed from the road and submitted to the laboratory for gradation analysis. The sampled locations are indicated on Map 5. The sieve size analysis of these are shown on Table 11 and gradation curves on Figures 8 and 9.

GRADATION CURVES OF GRANULAR 'A' FROM AMHERST QUARRIES (1969) LTD.  
SAMPLED FROM MUNICIPAL ROADS

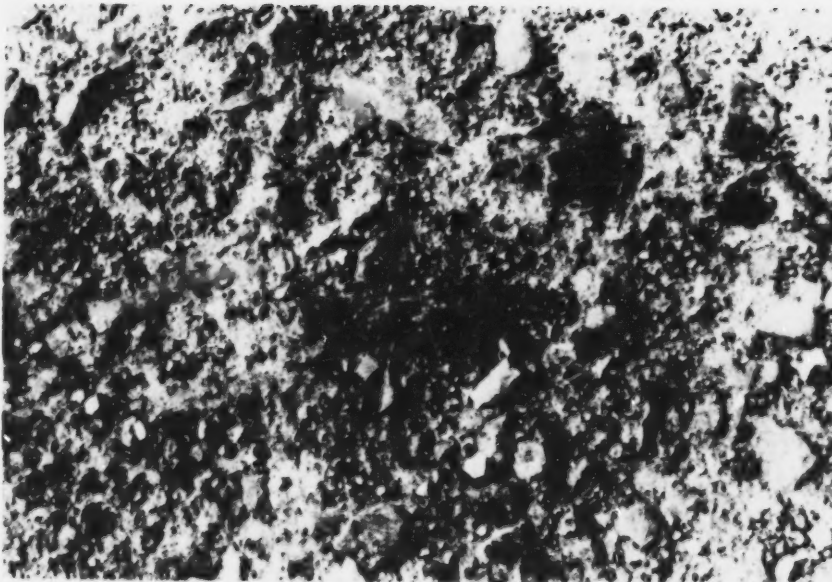
TYPICAL PERFORMANCE OF GRANULAR A  
FROM ALLIED CHEMICAL LTD. MCGREGOR QUARRY  
(cont'd)

Close up of road surface. Note the edges of stones also the well compacted nature of the surface.

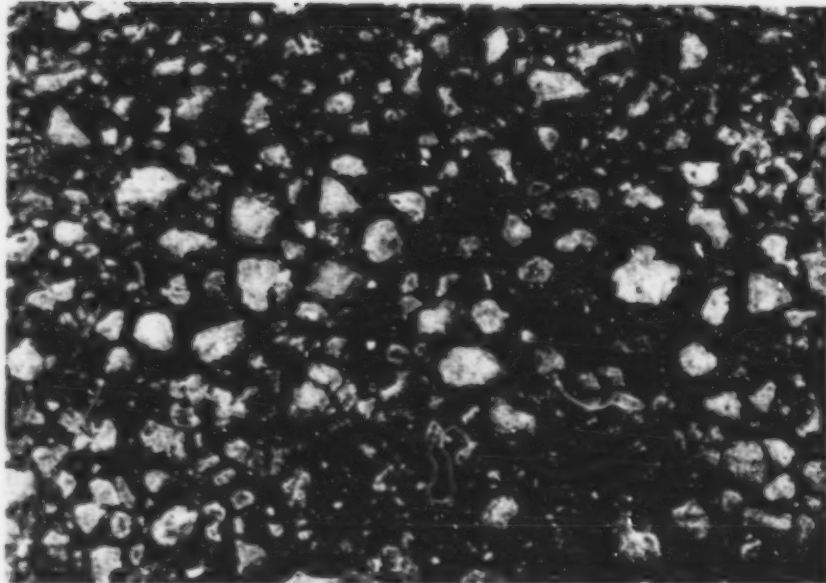
"Soupy" oversaturated condition of the granular surface during spring melting.

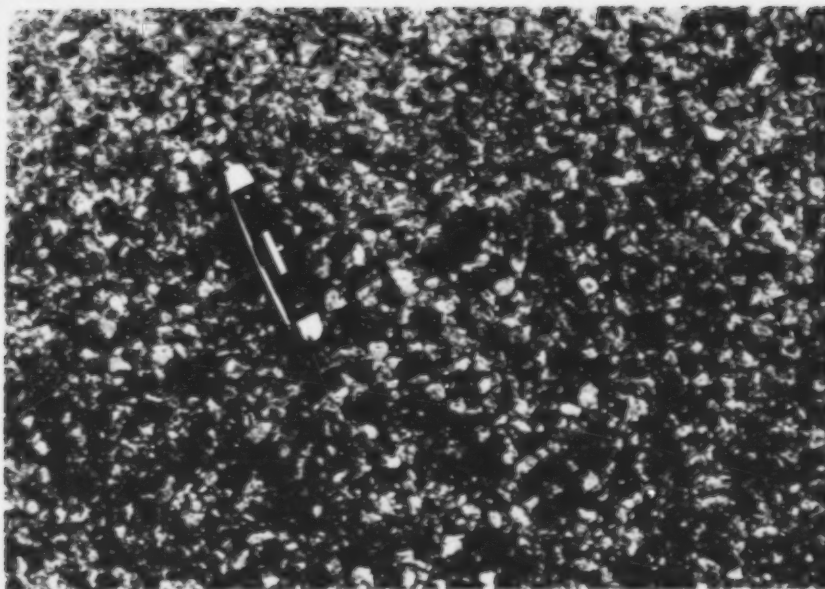
Photo 12

as above  
- close up

loose stone on the shoulder. The stone particles are slightly worn but do not show any deterioration. It should be noted that the performance exhibited was the result of relatively light traffic and a very limited use (if any) of de-icing road salts. The average performance is illustrated on Photos No. 11 to 13.

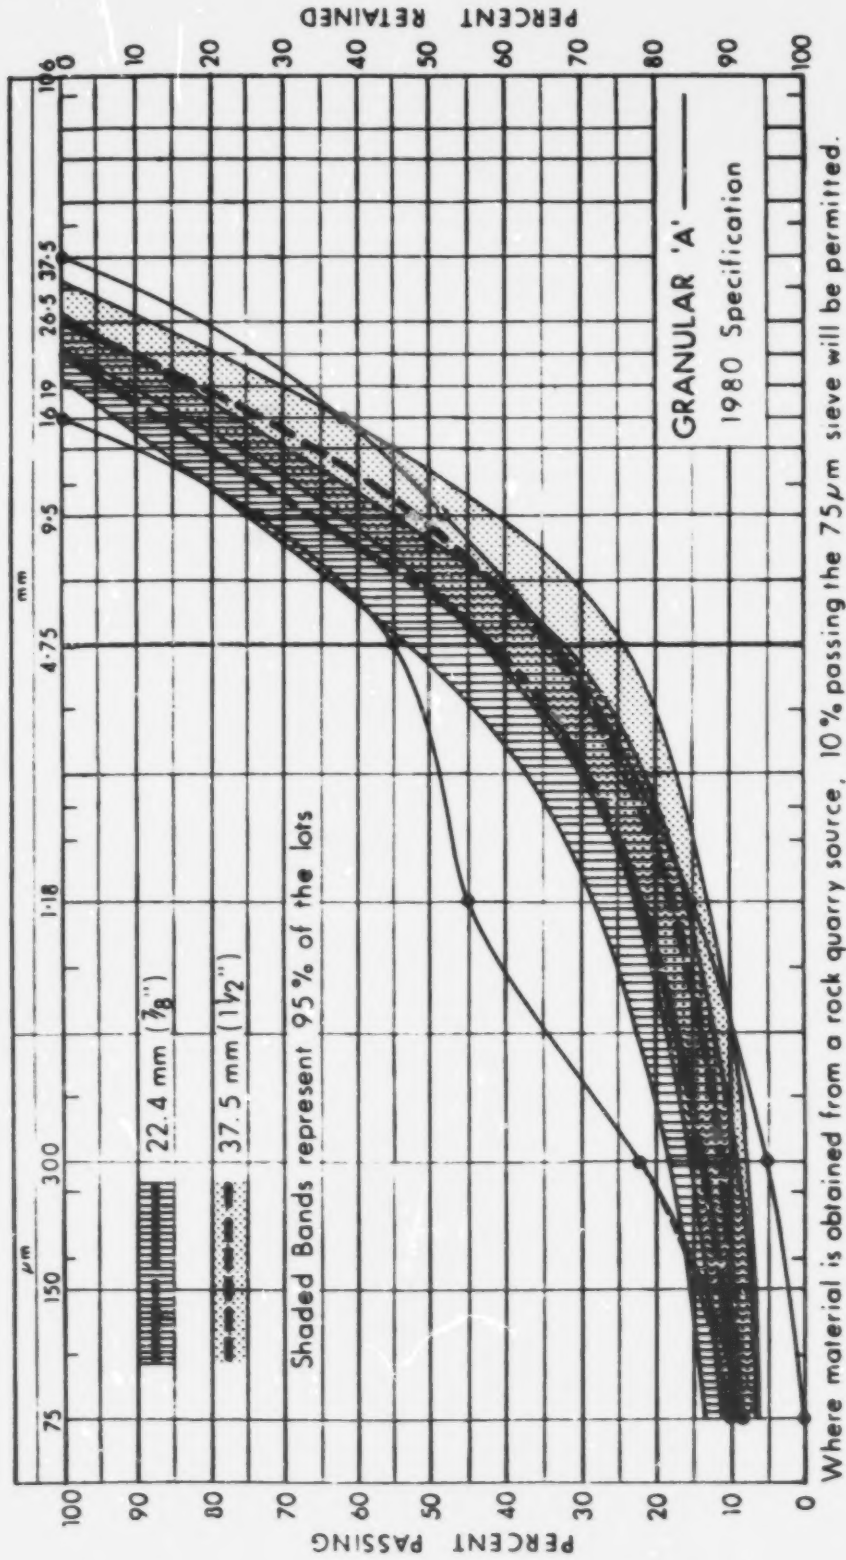
GRADATION CURVES OF GRANULAR A, E.C. ROW EXPRESSWAY

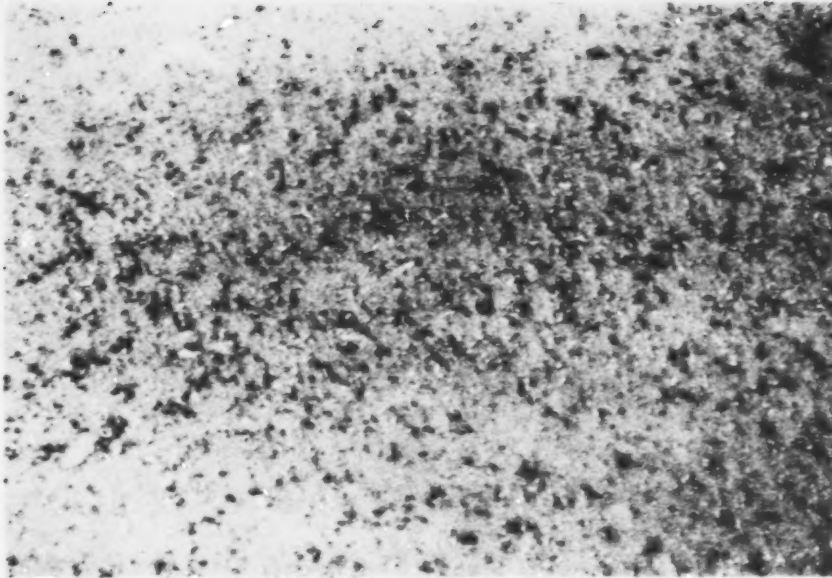
was also inspected. It was found that the particles were only very slightly affected by the traffic wear. In areas, the pavement shows loss of stones but it was observed to be the result of ravelling caused by excessive speed in paving in order to meet the designated completion date last fall. The pavement condition is shown on Photos No. 14, 15 and 16.

E.C. ROW EXPRESSWAY - WINDSOR

CONTRACT 80-43

Average pavement  
condition.

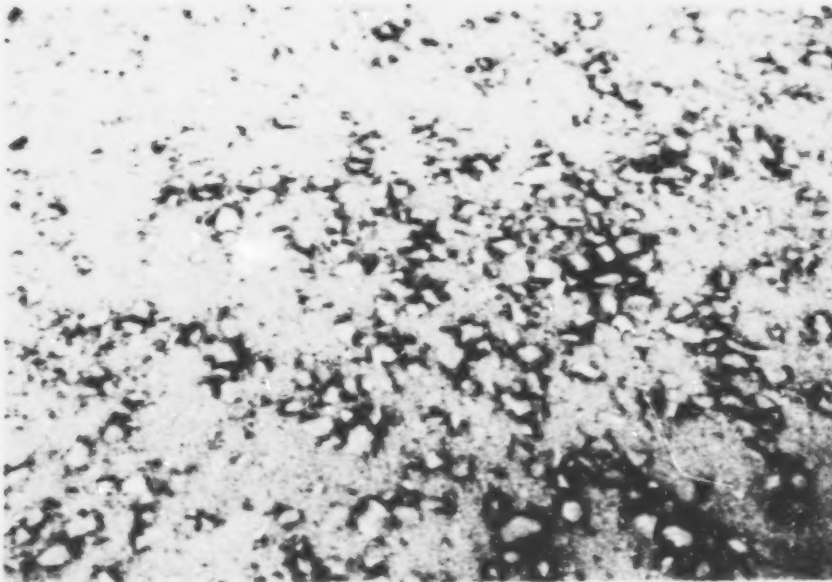
Photo 14

Close up of  
average pavement.

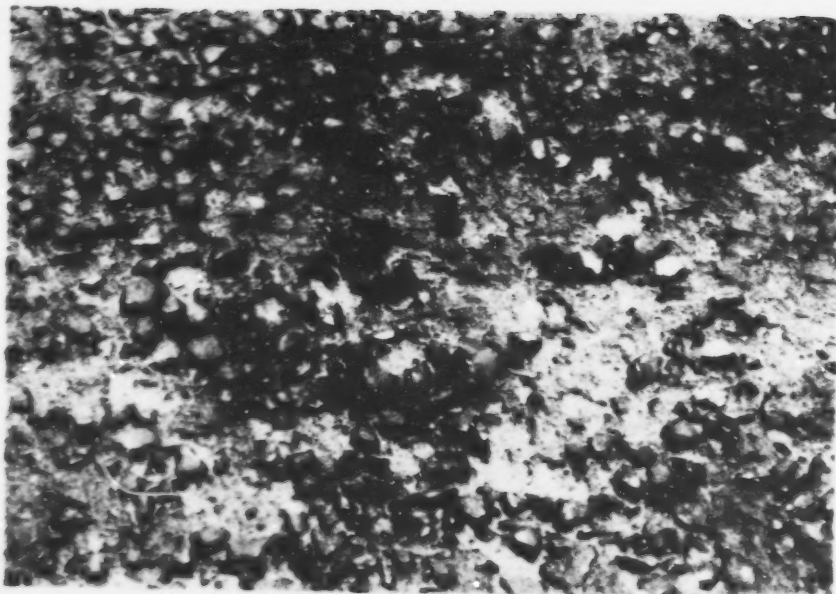
CONTRACT 80-43  
(cont'd)

Note:  
Loss of  
coarse aggregate.
